## Swimming Pool Decking Support Replacement

Project Category:	Structural replacement
Scope of Work:	Supply FRP structural profiles
Treadwell Products:	ArchitEX™ FRP Structural Profiles

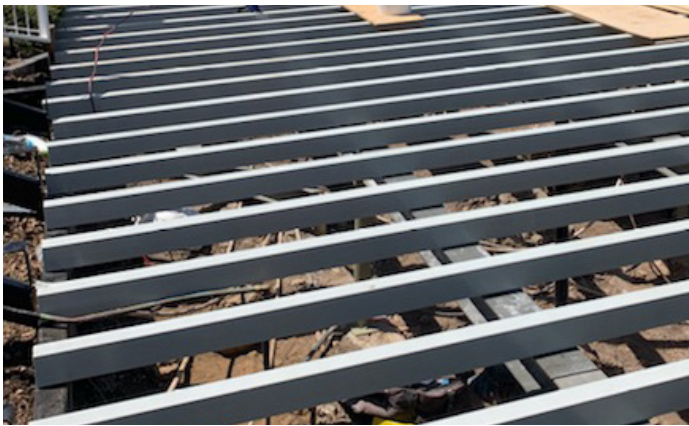
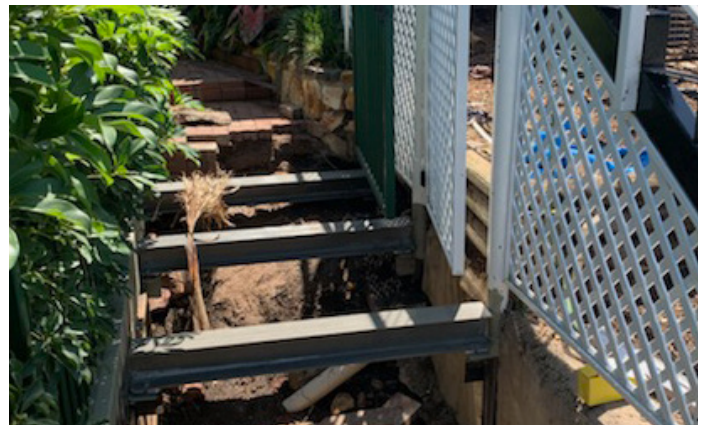
The decking support beams of our client's swimming pool had corroded and needed to be replaced. This was originally constructed from traditional materials and did not last long being exposed to the environment. New structural beams needed to be installed to ensure safety. As there was already a foundation, the new beams needed to be of a similar height and had to be able to be incorporated into the existing structure.

- 1 Treadwell had a ready range of structural sections from which to select the best suited product, coupled with sound technical advice.
- 2 ArchitEX™ FRP beams and sections were specified for the needs of this project. These were made from specially formulated resin that would withstand corrosion.
- 3 FRP brackets were supplied for beam to beam connections.
- 4 FRP is simply fabricated and modified on site. This means there is no need for any hot works permit.
- 5 Being lightweight and easy to install, FRP is very manageable during construction.
- 6 Given the nature of FRP, any system utilising it is virtually maintenance free, thus keeping maintenance costs as low as possible.
